The Benefits of Internal Coatings

Case study - kiln

Debra Ashley,
Specialized Coating
Technology, LLC, USA, describes
the benefits of internal coating
applications to cement kilns,
baghouses and other flue gas
equipment.

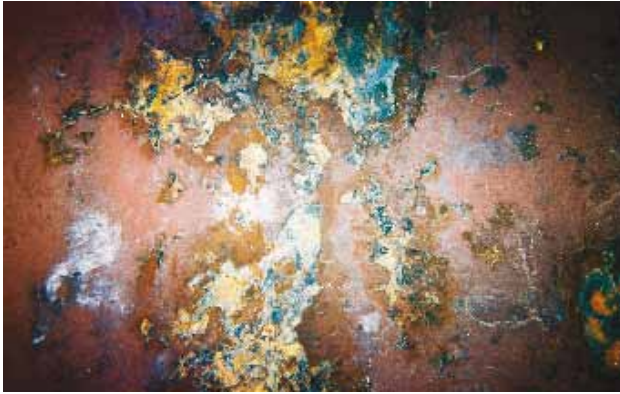
Figure 1. Corrosion of an untreated kiln.

thick. Inspection of this section took place during standard plant outage, following removal of the refractory brick. The appearance of substrate revealed severe corrosion. Numerous areas of pitted steel and orange peel delamination were apparent (Figure 1). The thickness of delamination appeared to be approximately 0.0625 in. steel loss.

The surface was abrasively blasted to SSPC -10, near white blast (0.001 in. profile). A heat and corrosive resistant coating was applied. This coating was an aqueous based, aluminium filled, silicon ceramic-based material. Coating was applied by spray method conventional system at 4.0 mm wet film thickness (wft) and would dry at 1.5 mm dry film thickness (dft) per coat for two coats, totalling 3.0 mm dft. The full procedure was performed within one eight hour shift. The coating was dry to touch within two hours after application, thus allowing refractors to re-enter to complete installation of new refractory without delay. The full remedy would occur when the plant returned to service.

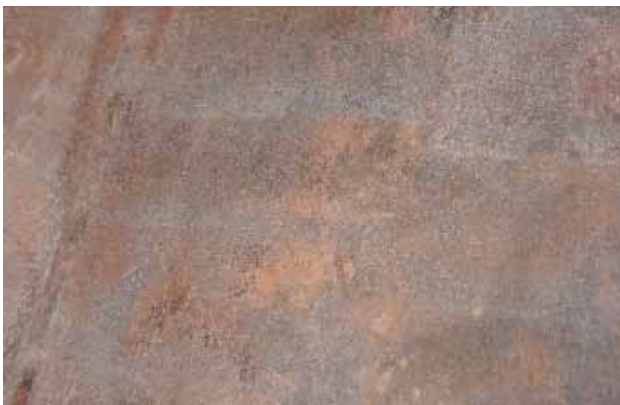
Figure 2. Inspection of 2001 kiln coating three years after application.

In March 2002, an additional section of kiln shell was awarded. Initial inspection revealed substrate appearance similar to the March 2001 inspection of the previous section. Preparation and application to this section was the same as in the previous application. During this 2002 outage, the applicator inspected the portion of kiln shell coating that was performed in March 2001. Inspection revealed no noticeable delamination of steel thickness, and much of the coating could still be seen intact (Figure 2).

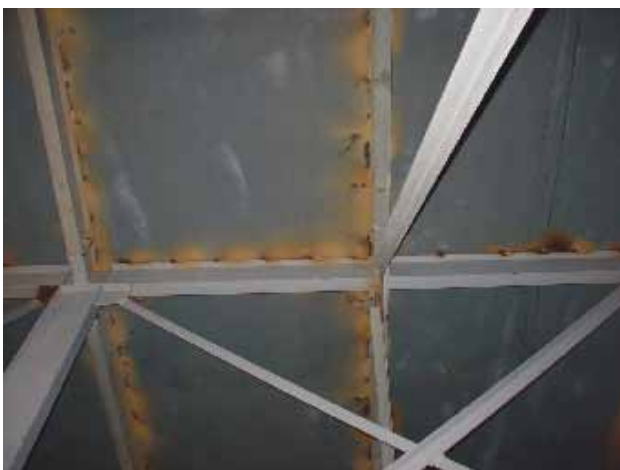
Figure 3. Internal baghouse inspection in 2004, prior to coating application.

The contract including coating internal baghouse walls, ceilings, floors, thimbles and hoppers; the steel had been newly erected, and the structural supports were precoated with a separate shop system. At the time the contract was awarded, the plant decided not to recoat the supports with speciality coating (Figure 3).

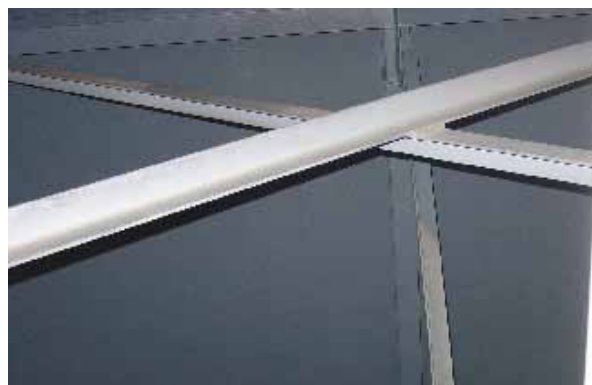
Figure 4. October 2004 - baghouse coating applied (excluding supports).

Steel was prepared by grit blasting to SSPC-10, near white blast (0.001 in. profile). A VOC compliant high build silicon and corrosion resistant, self-priming air dry coating was applied at three coats. Each coat was applied at 7 – 8 mm wft, which dried at 4 - 5 mm dft per coat, totalling 13 dft (Figure 4).

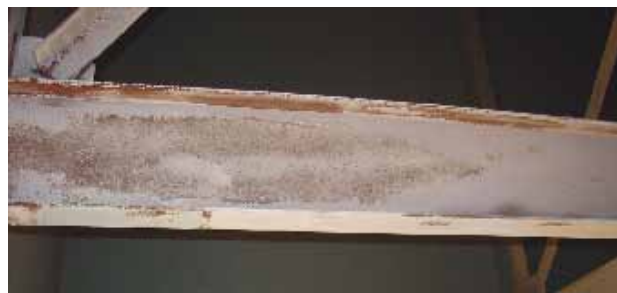
In February 2009, the company was called out to inspect the unit. Upon inspection, all coating applied in the 2004 application was still intact, with no appearance of density loss of coating. Signs of corrosion only appeared on the supports that had been precoated offsite by a separate shop system. The plant requested that those supports be blasted and coated during their ongoing February 2009 shutdown with the same speciality coating that had been applied previously in 2004. The applicator blasted and applied three coats of the same material to the same specifications as 2004, and the project was completed within seven days (Figures 5 and 6).

Figure 5. 2009 Inspection of 2004 baghouse coating revealed coating intact, however corrosion attack to supports is evident.

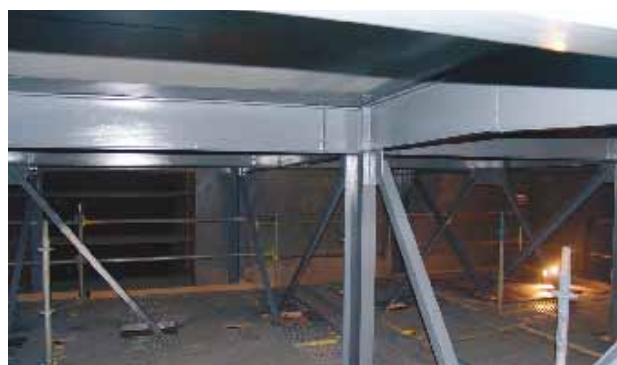
Figure 6. Baghouse coating applied to supports in 2009.

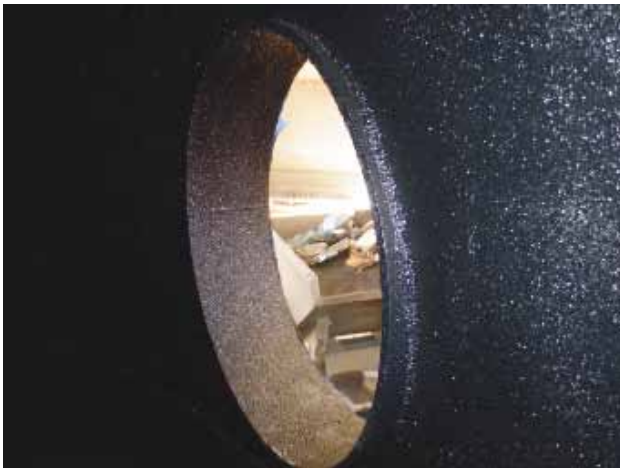
Figure 7. Internal stack coating applied in 2009.

In December 2009, inspection of the sample revealed that the coating was intact and there was no evidence of loss of material, or penetration, or deterioration. At this time, the owner requested that the applicator apply another sample of the product to the lower 20 ft. dia. of the interior portion of the stack shell. Due to the permeable state of the lower internal wall, as well as the open joint gaps between the plates, it was necessary that this steel be cleaned and sealed before the coating was applied to ensure a clean and tight seal. Thickness of the wall here was approximately 0.5 in. plate. The applicator grit blasted the area to SSPC-10, near white blast, and then power washed the area. This was followed by another grit blast to SSPC-10. A heat tolerant calk was applied to the joints for a tighter seal. The coating - the Hi-Build Epoxy Hybrid system with rubber additive - was then applied in two coats. Total dft was approximately 120 - 125 mm or 0.125 in. thickness (Figure 7).

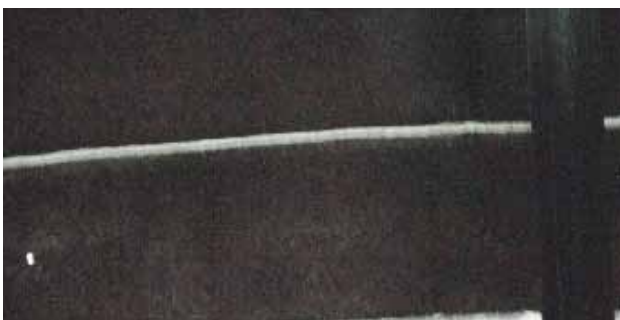
Figure 8. 2010 inspection of flare stack.

Operating temperature of the stack is between 245 - 250 °F, although it occasionally cycles at approximately 350 °F. In May 2010, Specialized Coating Technology had the opportunity to perform an inspection. The coating was intact with no evidence of loss or delamination. This coating study is ongoing and will be inspected at the next outage (Figure 8).

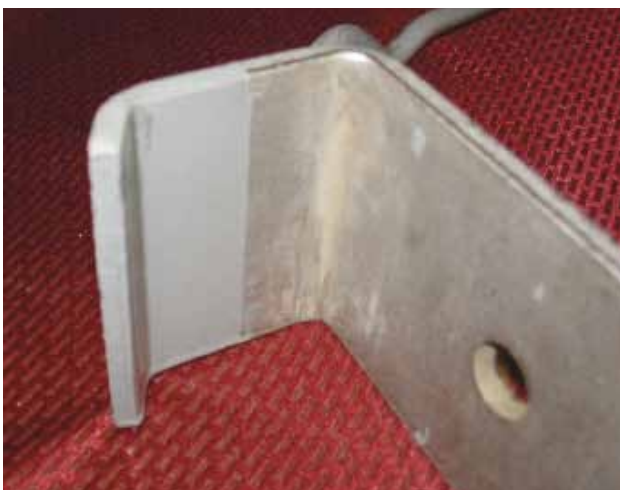
Figure 9. August 2009, coating of refractory clip.

In August 2009, Specialized Coating Technology was presented with several refractory anchors and clips, various sizes and shapes. These anchors and clips were new and made of 314 and 310 stainless steel. The surfaces of the clips and anchors were cleaned by hand and using chemicals. Portions of the units were taped off to provide a clean surface for welding. The applicator used two different materials for coating these units; both coatings were compatible with refractory installation materials. The first material was a Hi-Build Novolac-low viscosity epoxy, designed for highly corrosive applications as high as 500 °F. The coating was sprayed on at 6 - 7 mm wft (5 - 6 mm dft); total dft was 10 - 12 mm. The second coating used was an inorganic ceramic aqueous-based coating, aluminium filled. This was designed to withstand heat to 1400 - 1500 °F, and resistant to thermal shock, oxidation and chemical corrosion. The coating was sprayed on at 4 m wft per coat (2 - 3 mm dft); total dft was 6 mm dft (Figure 9). This coating is being monitored.
