The benefits of internal coating and other flue gas vessels

DEBRA ASHLEY, ASHCOAT LLC, CANYON LAKE, TEXAS, USA

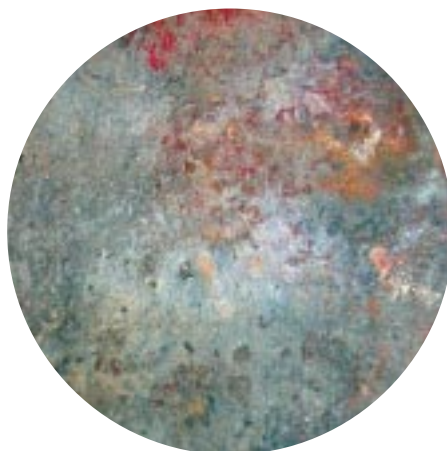
In March 2002, the company was presented with a different portion of interior kiln shell wall with the same area. It would have had the same original shell thickness and was experiencing the same type of deterioration. The company was also allowed to investigate part of the steel that had been coated one year previously and no further delamination of steel thickness was found. The coating was still evident on much of the surface and the substrate appeared smooth, with no evidence of deterioration (see Figure 2).

Figure 2: The kiln wall coating one year after application.

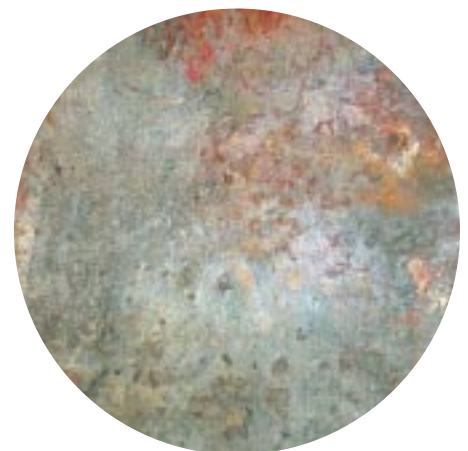
Figure 3: The kiln wall three years after application.

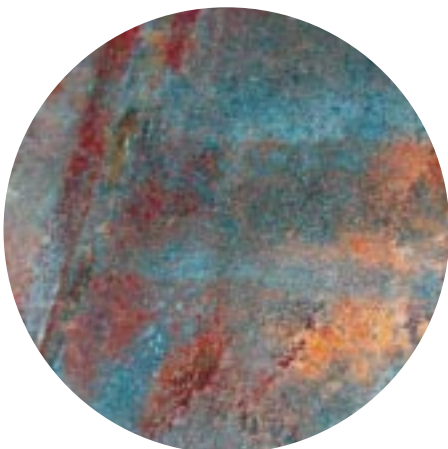
Figure 4: The same wall four years after application.

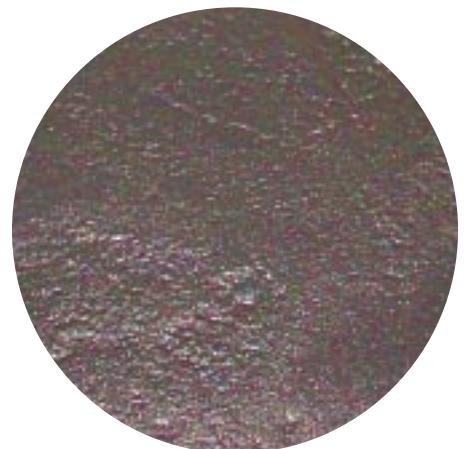
silicone-based coating was spray-applied to a prepared surface at approximately 7 wet mils per coat which would dry at 4–5dft (dry film thickness) per coat. Three coats were applied to achieve a total dry film thickness of 14–15dft. Research will be undertaken the status and condition of the coating in the future (see Figure 6).

Figure 6: The coating applied to the internal wall of a flare stack.
